A Holiday Shocker!

Viki Carpenter - Cardiac Physiologist

Addenbrookes Hospital

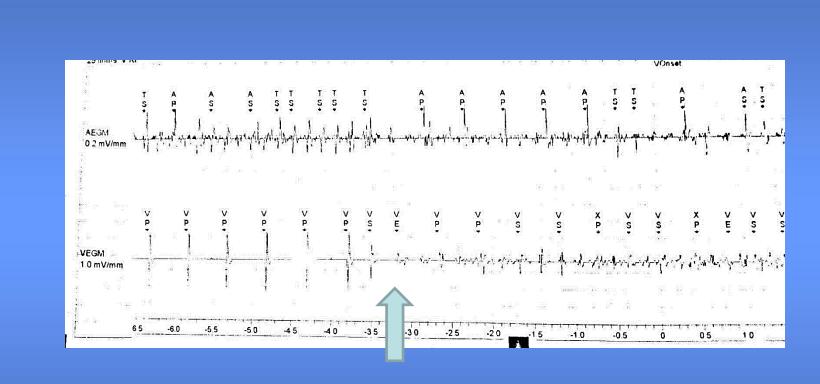
Interrogation of device

VF initiated by PVC

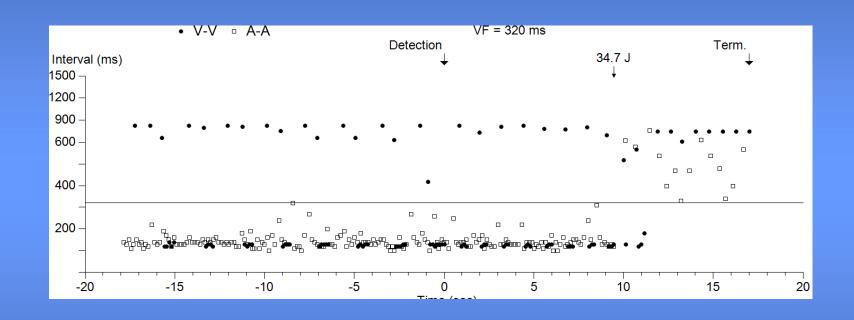
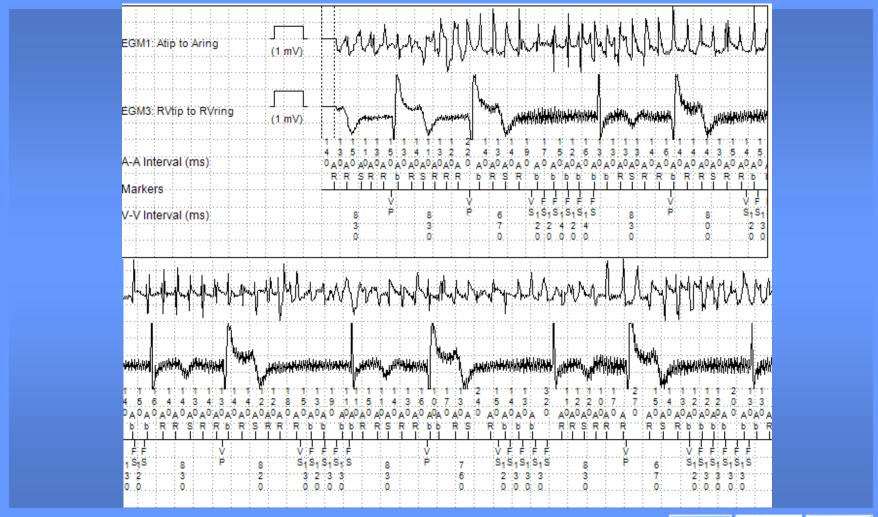
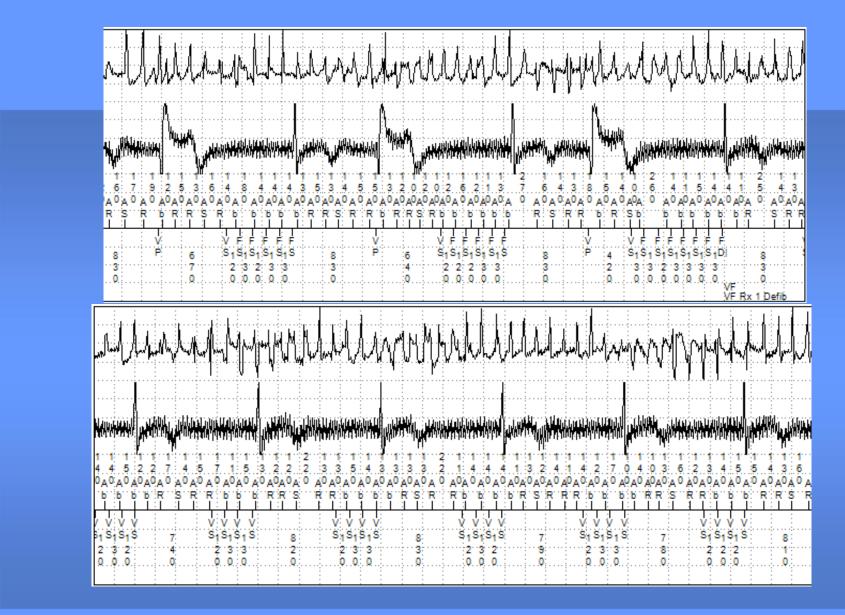
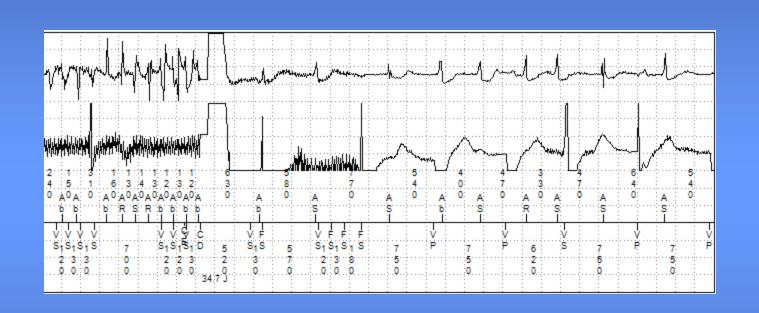
VF episode

- All other lead tests satisfactory
- 44 short V-V episodes
- 1 episode of treated VF
- 5 High rate NS episodes
- 100% AF

- Suspected electrical fault with Jacuzzi
- Hotel owner was patients son
- Suggested a phone call may be in order
- He closed pool and Jacuzzi for electrical testing
- Asked patient to let me know if no problem with electrics

- Contacted patient
- Reported earth leakage from Jacuzzi
- All mended
- Everyone happy!
